The process of examining a used piston can tell a mechanic helpful information on the condition of an engine. When an engine failure occurs, the piston is likely to take the brunt of the damage. A careful examination of the piston can help a mechanic trace the source of a mechanical or tuning problem. This technical article serves as a guide for the most common mechanical problems that plague engines.

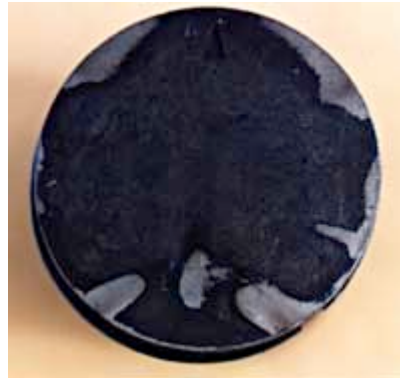
PERFECT BROWN CROWN

The crown of this piston shows an ideal carbon pattern. The transfer ports of this two-stroke engine are flowing equally and the color of the carbon pattern is chocolate brown. That indicates that this engine's carb is jetted correctly.

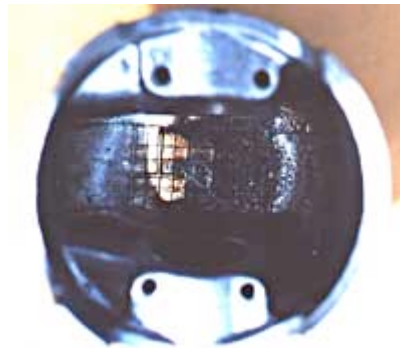
BLACK SPOT HOT

The underside of this piston has a black spot. The black spot is a carbon deposit that resulted from pre-mix oil burning on to the piston because the piston's crown was too hot. The main reasons for this problem are overheating due to too lean carb jetting or coolant system failure.

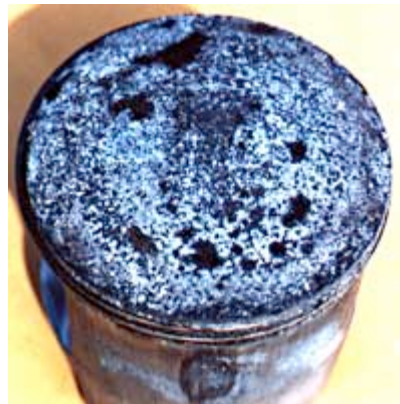
ASH TRASH

This piston crown has an ash color, which shows that the engine has run hot. The ash color is actually piston material that has started to flash (melt) and turned to tiny flakes. If this engine was run any longer, it probably would've developed a hot spot and hole near the exhaust side and failed. The main causes of this problem are too lean carb jetting, too hot spark plug range, too far advanced

ignition timing, too much compression for the fuel's octane, or a general overheating problem.

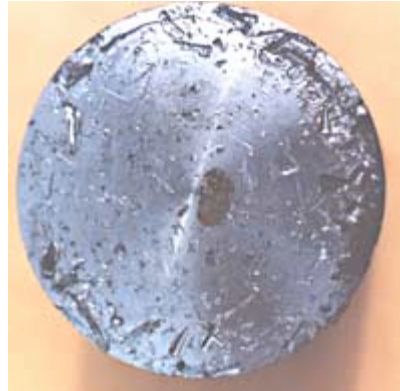
SMASHED DEBRIS

This piston crown has been damaged because debris entered the combustion chamber and was crushed between the piston and the cylinder head. This engine had a corresponding damage pattern on the head's squish band. The common causes of this problem are broken needle bearings from the small or big end bearings of the connecting rod, broken ring ends, or a dislodged ring centering pin. When a problem like this occurs, it's important to locate where the debris originated. Also the crankcases must be flushed out to remove any left over debris that could cause the same damage again. If the debris originated from the big end of the connecting rod, then the crankshaft should be replaced along with the main bearings and seals.

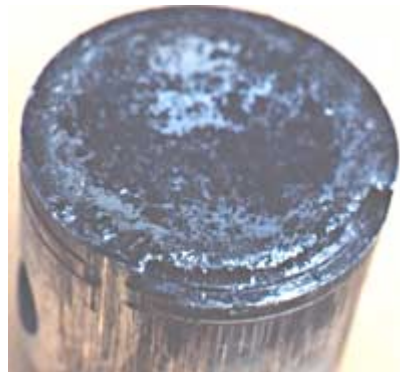
CHIPPED CROWN DROWNED

This piston crown chipped at the top ring groove because of a head gasket leak. The coolant is drawn into the combustion chamber on the down-stroke of the piston. When the coolant hits the piston crown it makes the aluminum brittle and it eventually cracks. In extreme cases the head gasket leak can cause erosion at the top edge of the cylinder and the corresponding area of the head. Minor leaks of the gasket or o-ring appear as black spots across the gasket surface. An engine that suffers from coolant being pressurized and forced out of the radiator cap's vent tube, is a strong indication of a

head gasket leak. In most cases the top of the cylinder and the face of the cylinder head must be resurfaced when a leak occurs. Most mx bikes have head stays mounting the head to the frame. Over time the head can become warped near the head stay mounting tab, because of the forces transferred through the frame from the top shock mount. It's important to check for warpage of the head every time you rebuild the top end.

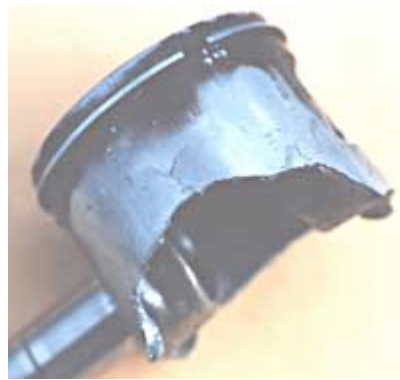
SHATTERED SKIRT

The skirts of this piston shattered because the piston to cylinder clearance was too great. When the piston is allowed to rattle in the cylinder bore, it develops stress cracks and eventually shatters.

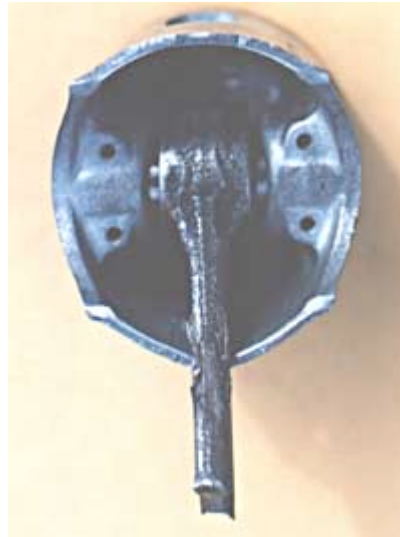
SNAPPED ROD

The connecting rod of this engine snapped in half because the clearance between the rod and the thrust washers of the big end was too great. When the big end bearing wears out, the radial deflection of the rod becomes excessive and the rod suffers from torsion vibration. This leads to connecting rod breakage and catastrophic engine damage. The big end clearance should be checked every time you rebuild the top end. To check the side clearance of the connecting rod, insert a feeler gauge between the rod and a thrust washer. Check the maximum wear limits in your engine's factory service manual.

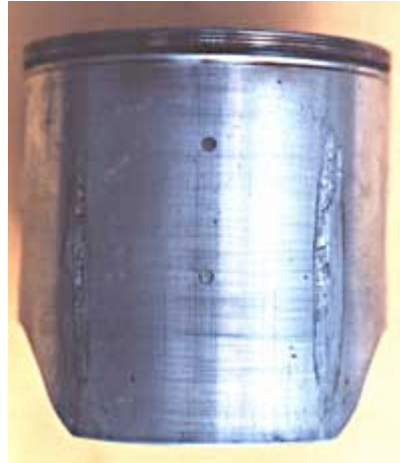
FOUR-CORNER SEIZURE

This piston has vertical seizure marks at four equally spaced points around the circumference. A four-corner seizure is caused when the piston expands faster than the cylinder and the clearance between the piston and cylinder is reduced. Another common problem of this type is a single point seizure on the center of the exhaust side of the piston. However this occurs only on cylinders with bridged exhaust ports. The main causes for this problem are too quick warm-up, too lean carb jetting (main jet), or too hot of a spark plug range.

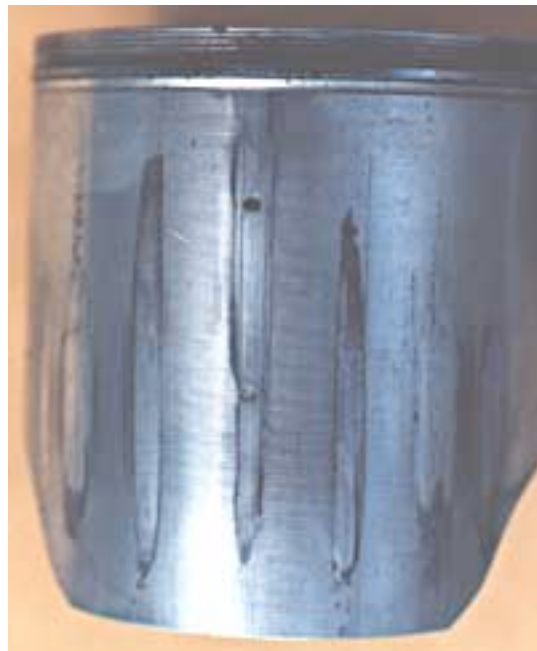
MULTI-POINT SEIZURE

This piston has many vertical seizure marks around the circumference. This cylinder was bored to a diameter that was too small for the piston. As soon as the engine started and the piston started its thermal expansion, the piston pressed up against the cylinder walls and seized. The optimum piston to cylinder wall clearances for different types of cylinders vary greatly. For example a 50cc composite plated cylinder can use a piston to cylinder wall clearance of .0015 inches, whereas a 1200cc steel-sleeved cylinder snowmobile set-up for grass drags will need between .0055 to .0075 inches. For the best recommendation on the optimum piston to cylinder clearance for your engine, look to the specs that come packaged with the piston or consult your factory service manual.

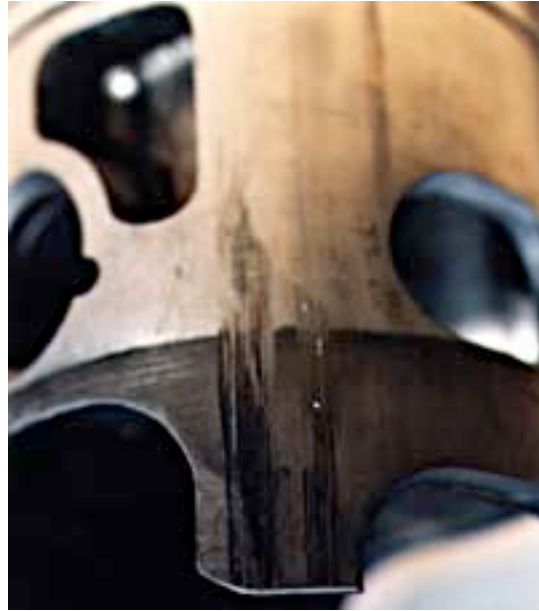
INTAKE SIDE SEIZURE

This piston was seized on the intake side. This is very uncommon and is caused by only one thing, loss of lubrication. There are three possible causes for loss of lubrication, no pre-mix oil, separation of the fuel and pre-mix oil in the fuel tank, water passed through the air-filter and washed the oil film off the piston skirt.

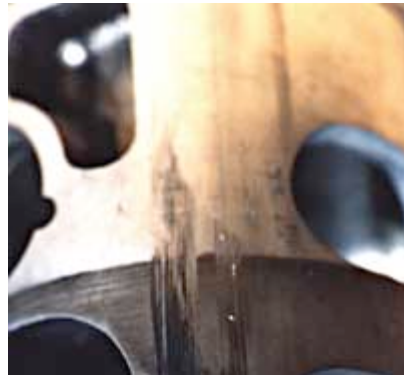
COMPOSITE FLAKING

Most two-stroke cylinders used on motorcycles and snowmobiles, have composite plated cylinders. The composite material is made of tiny silicon carbide particles. The electro-plating process enables the silicon carbide particles to bond to the cylinder wall. The particles are very hard and sharp, they don't bond to the ports so the manufacturer or reconditioning specialist must thoroughly clean the cylinder. Sometimes the silicon carbide "flashing" breaks loose from the ports and becomes wedged between the cylinder and the piston. This causes tiny vertical scratches in the piston. This problem isn't necessarily dangerous and doesn't cause catastrophic piston failure, but it should be addressed by thoroughly flushing the cylinder and ball-honing the bore to redefine the cross-hatching marks. Normally you will need to replace the piston kit because the scratches will reduce the piston's diameter beyond the wear spec.

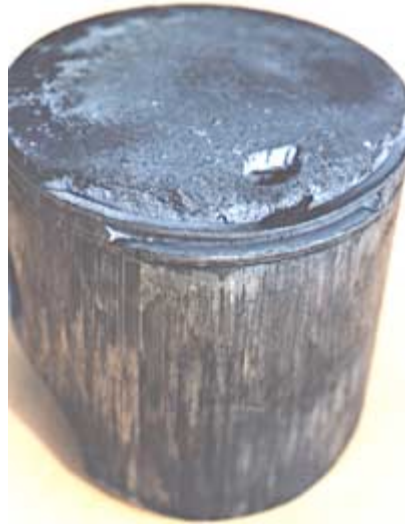
BURNT-OUT BLOW-HOLE

This piston was overheated so badly that a hole melted through the crown and collapsed the ring grooves on the exhaust side. Normally the piston temperature is higher on the exhaust side so catastrophic problems will appear there first. There are several reasons for a failure like this, here are the most common; air-leak at the magneto side crankshaft seal, too lean carb jetting, too far advanced ignition timing or faulty igniter box, too hot of a spark plug range, too high of a compression ratio, too low octane fuel.

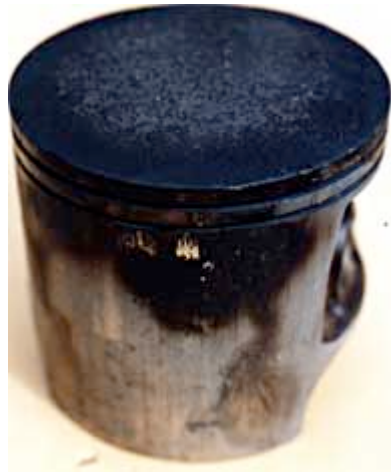
BLOW-BY

This piston didn't fail in operation but it does show the most common problem, blow-by. The rings were worn past the maximum ring end gap spec, allowing combustion pressure to seep past the rings and down the piston skirt causing a distinct carbon pattern. Its possible that the cylinder walls cross-hatched honing pattern is partly to blame. If the cylinder walls are glazed or worn too far, even new rings won't seal properly to prevent a blow-by problem. Flex-Hones is a product available at most auto parts stores. They can be used to remove oil glazing and restore cross-hatch honing marks that enable the rings to wear to the cylinder and form a good seal. If you purchase a Flex-Hone for your cylinder, the proper grit is 240 and the size should be 10% smaller than the bore diameter.
